Manhole Inspection Summary

Manhole # S09GG1012MH

Location Address: **3025 W COLD SPRING LANE** Cross Street: **WABASH AVE**

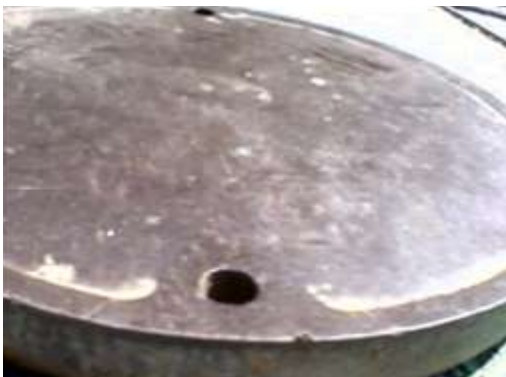
Defect 3

Type: **Sanitary** Condition: **Cracked** Cover Material: **Cast Iron**

CRACKED AND WORN COVER

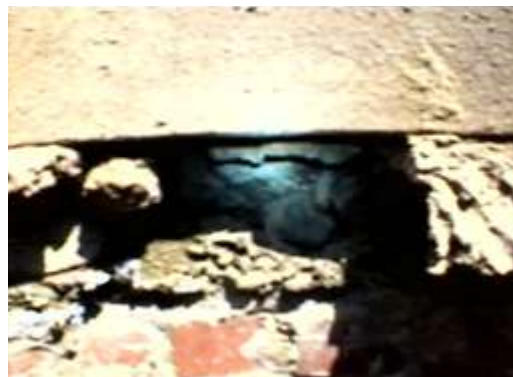
Defect 2

Condition: ☐ Sound ☐ Cracked ☐ Root Intrusion ☒ **Loose Brick** ☒ **Deteriorated**

LOOSE BRICKS / DETERIORATION OF CHIMNEY

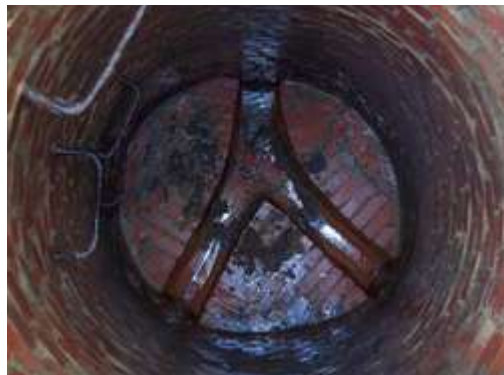
Defect 4

Condition: ☐ Sound ☐ Cracked ☐ Root Intrusion ☐ Deteriorated ☐ Leaks ☒ **Debris**

evidence surcharge and debris

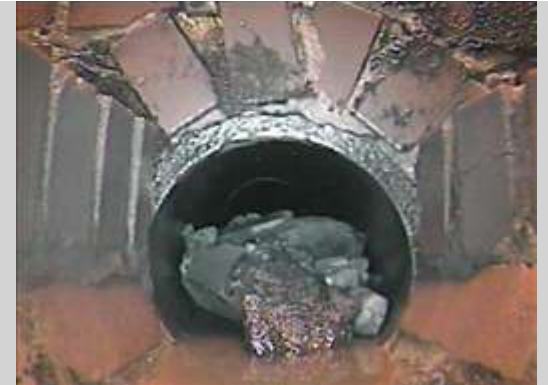
12 O'Clock Outflow

Deposits: ☐ None ☐ Mud ☐ Sludge ☒ **Debris** ☐ Grease

Silt Depth: **8** (in.) Deposits Extent: **Heavy**
